Subject: CR Kendall Mine Closure Environmental Impact Statement  
Hydrogeologic Data Summary Technical Memorandum

Environmental Impact Statement  
CR Kendall Mine Closure  
Fergus County, Montana

**Technical Memorandum**  
**Hydrogeologic Data Summary**

February 24, 2004

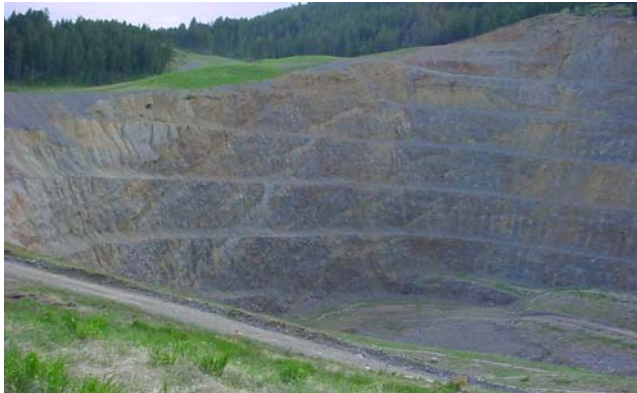
*Photo1  
South Side of Muleshoe Pit, CR Kendall Mine view  
looking south at steeply east dipping beds of Madison  
Limestone, June 2, 2003.*

Madison Limestone. This was also observed during a site inspection on June 2003 downstream of Little Dog Spring where all surface flow is lost in the drainage at the Madison Limestone contact with the Synenite Porphyry (See Section 5 for additional discussion of Little Dog Spring).

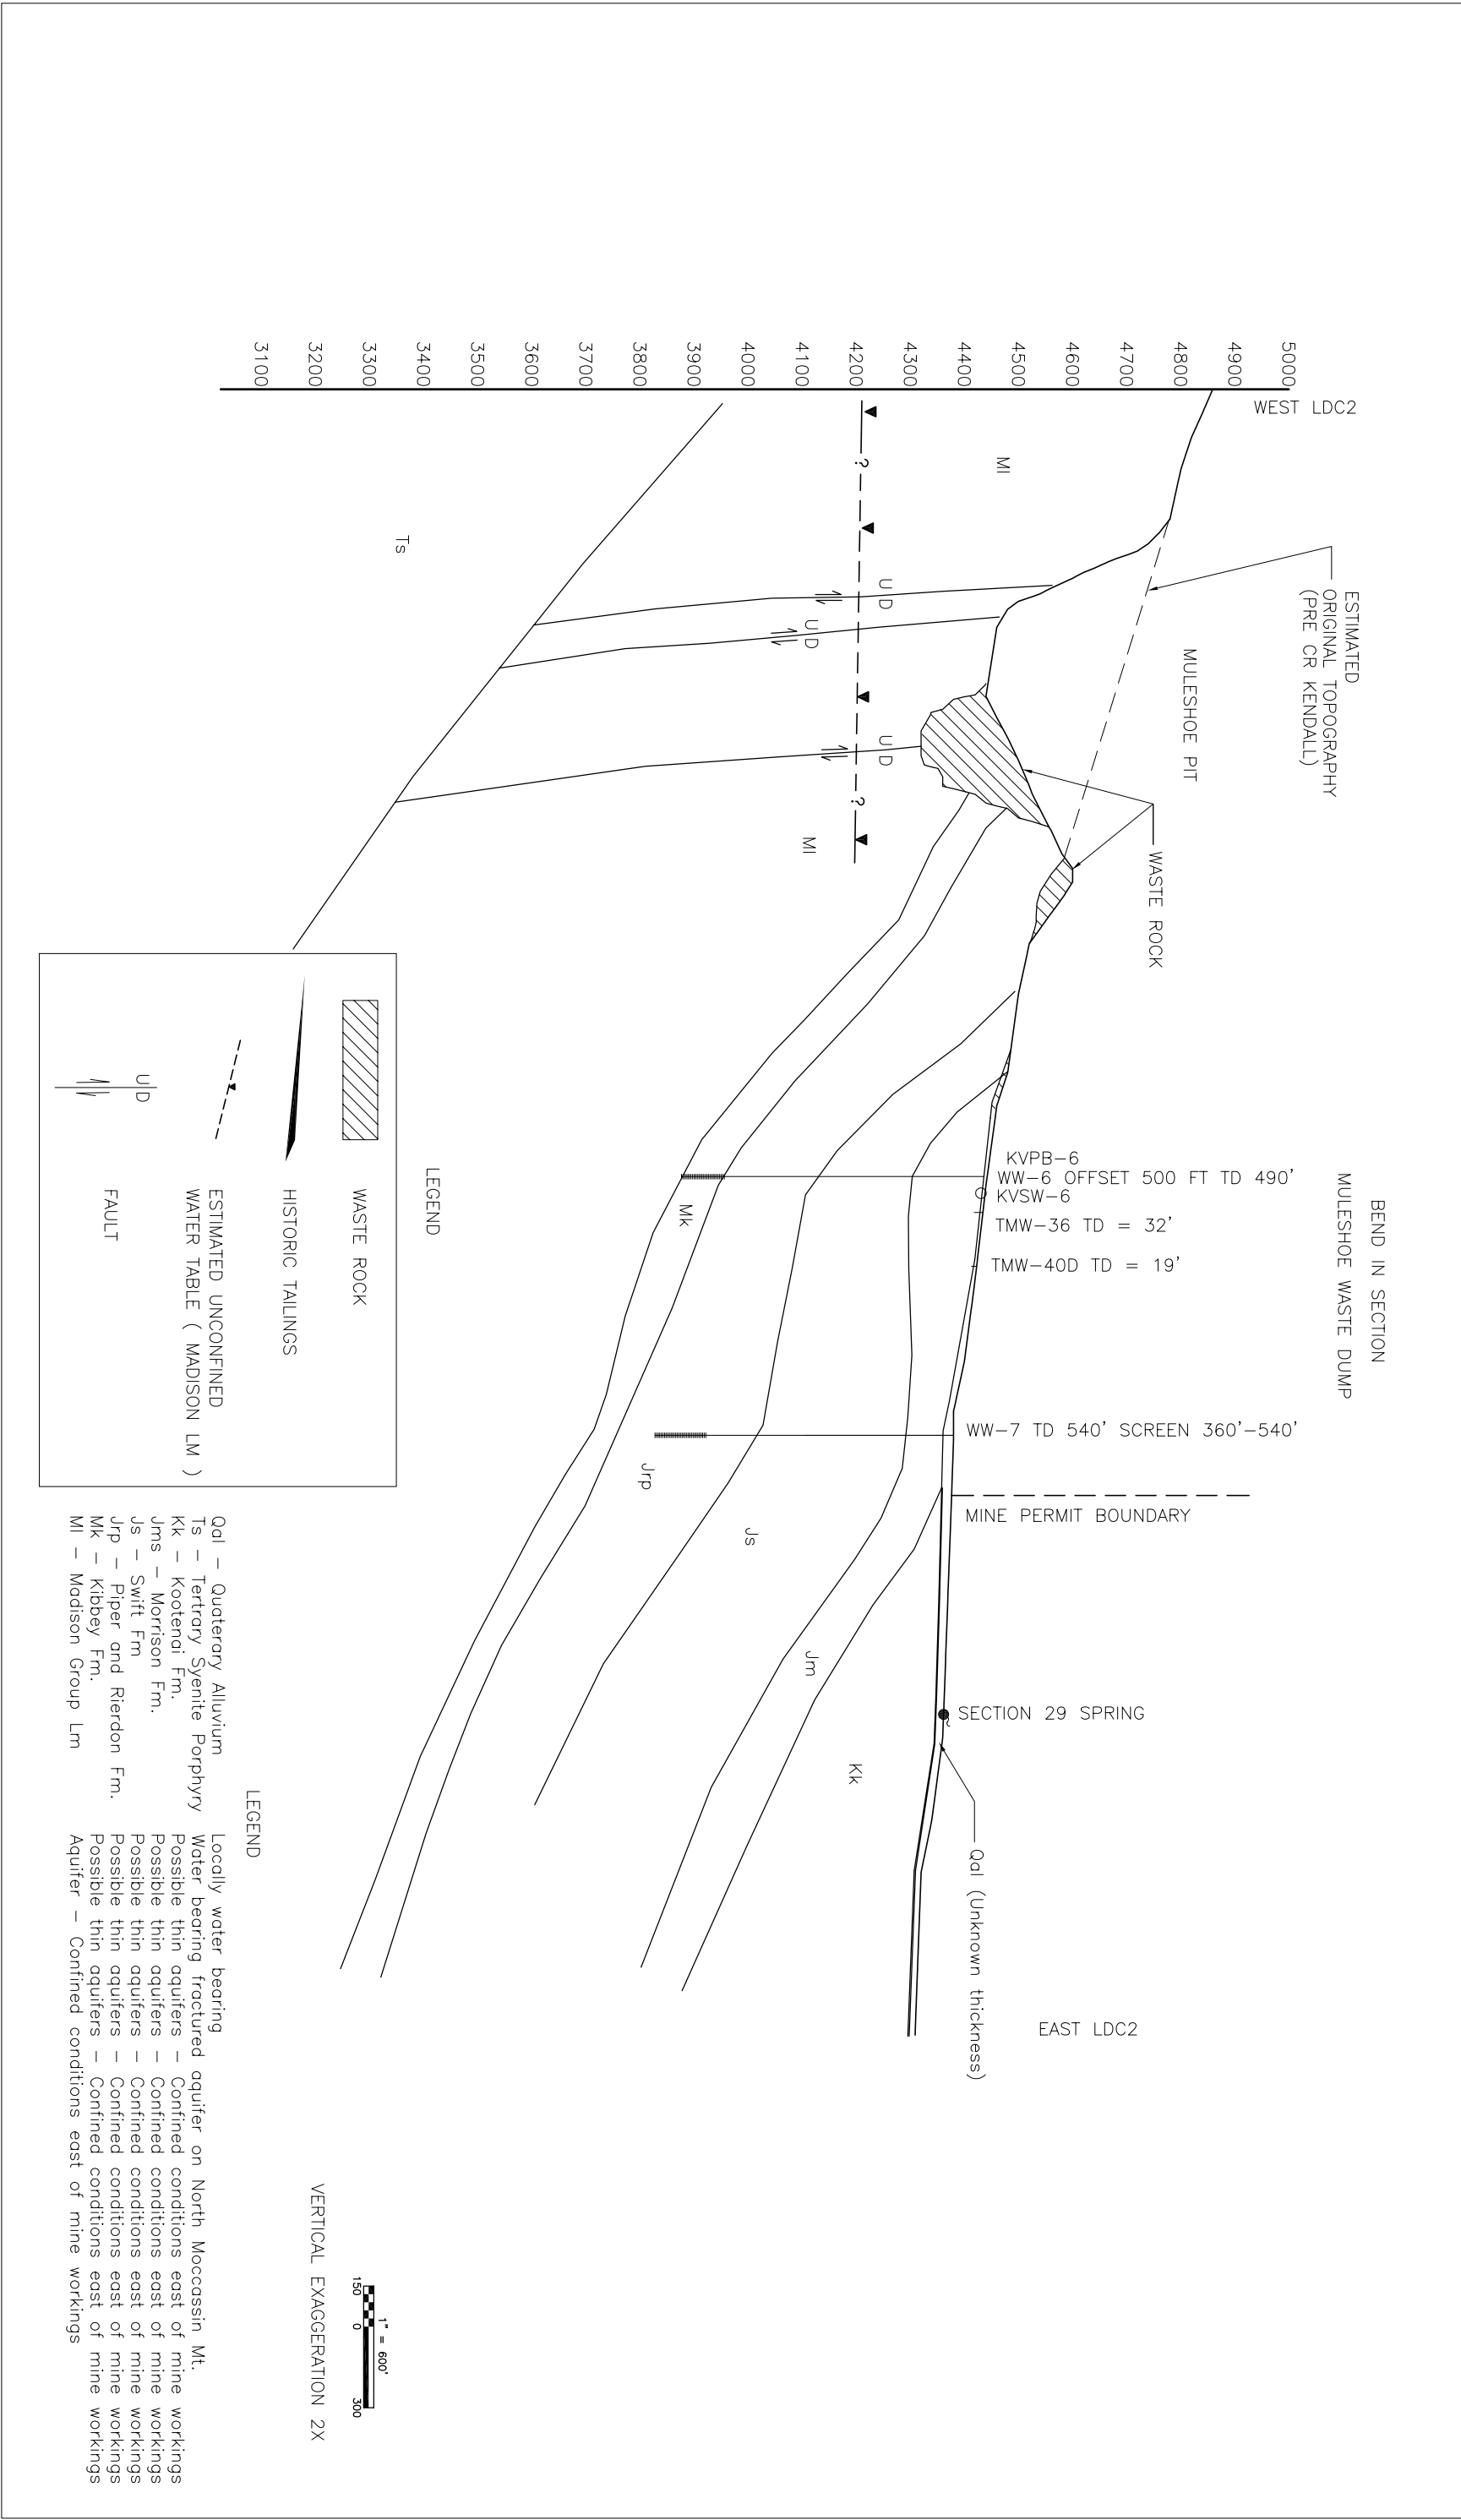
Figure 3  
Hydrogeological Cross-Section Little Dog Creek 2

The south branch of the drainage, referred to as the Muleshoe Branch, contains three monitoring wells (TMW-36, TMW-40D, and TME-41S) and the collector well KVPB-6 which is part of the groundwater pump-back system. Monitoring data indicate that the shallow groundwater quality has been impacted by mining operations. Water quality in bedrock supply wells appears to be good; however, no deep monitoring wells are present to evaluate bedrock hydrogeology and flow paths. Cross-sections of the Little Dog Creek Drainage are shown in Figures 2 (North Fork) and Figure 3 (South Fork).

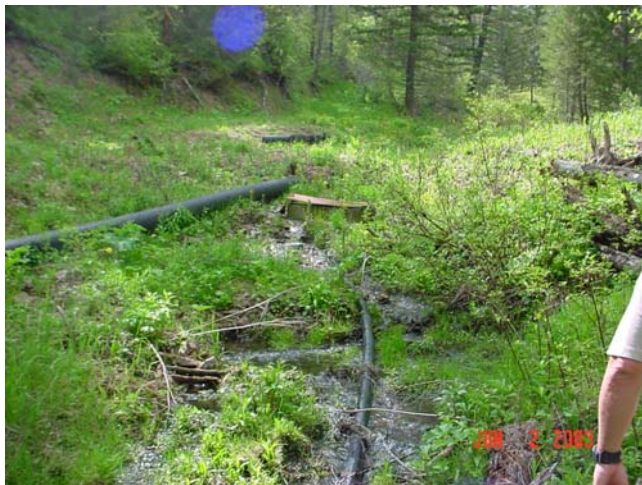
Little Dog Creek is located south of Dog Creek and was bisected by recent mining operations. In the headwaters area in the North Moccasin Mountains on BLM property is a relatively large spring known as Little Dog Spring (Photo 2). The spring apparently discharges from fractured Tertiary Syenite and the flow is reported to be perennial although no gauging records are available. As previously mentioned, a portion of the spring flow is piped to the Section 29 Spring to augment flow below the mine groundwater pump-back system. No surface flow has been reported in the

Little Dog Creek drainage entering the mine due to infiltration into the Madison Limestone which occurs approximately 1,000 feet west of the mine on BLM property. Brief surface flows may occur in the early spring months where heavy runoff combined with frozen ground conditions may allow for surface flow across the Madison Limestone outcrop to the mine site.

*Photo 2  
Little Dog Spring Discharge Area. View looking west.  
Spring collection box in center of photograph, June 2, 2003*

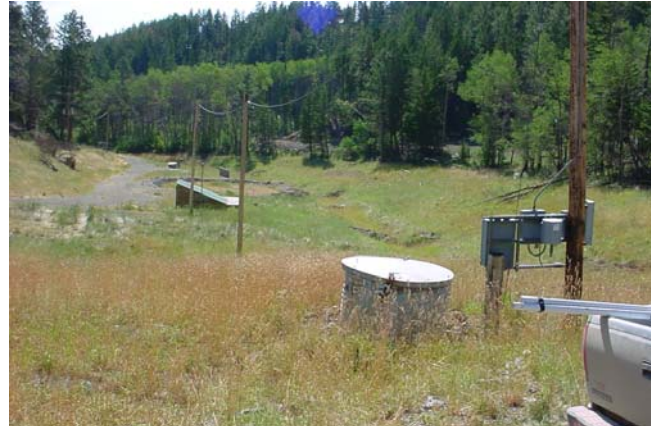
completed in the alluvium (TMW-30 and TMW-30A) and the pump-back collector well KVPB-2 (Photo 3). TMW-30 is not being monitored and is predominantly dry. Since installation of the pump-back system, surface flows at monitoring stations have decreased and the Peters Spring downstream of the pump-back collector well went dry.

*Photo 3  
Pumpback System Collector Well KVPB-2 and Barnes-King  
Gulch. View looking east, July 24, 2003*
